<i>Seabed Sampling and Baited Camera Operations</i>	
Vessel	R/V Ocean Veritas
Summary Report Number	12
Operating equipment	MAXI Corer (8 core unit)
Date	12 October 2010
Completed casts (12 hr)	11
Report compiled by	Emily Gould

Seabed Sampling Locations

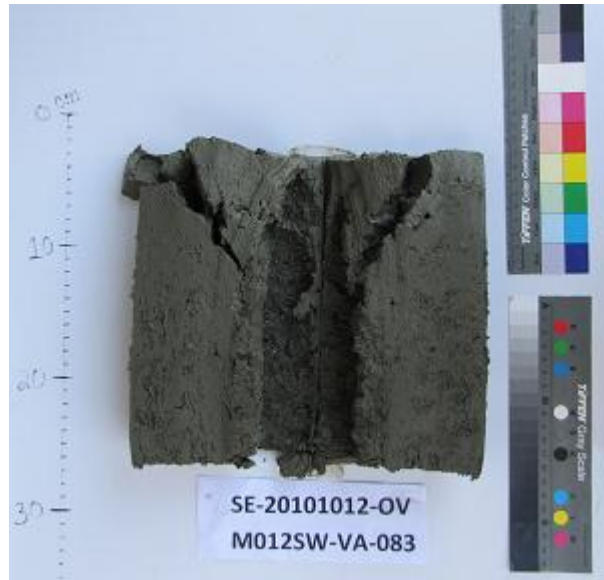
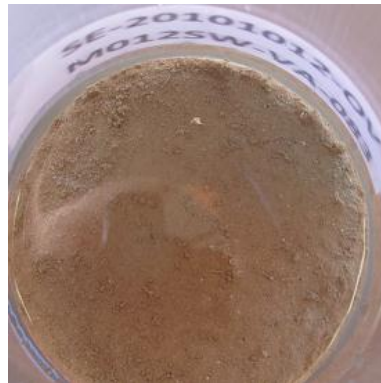
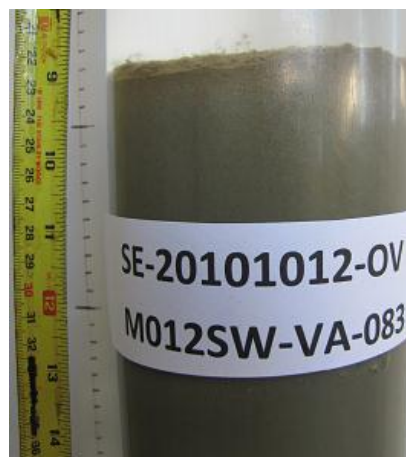
Station M012S

Cores recovered: 8 of 8

Recovery: 31 cm

Recovery: 29 cm

Description: Olive grey, very soft, homogenous silty clay, becoming soft.

Biota: Polychaetes.

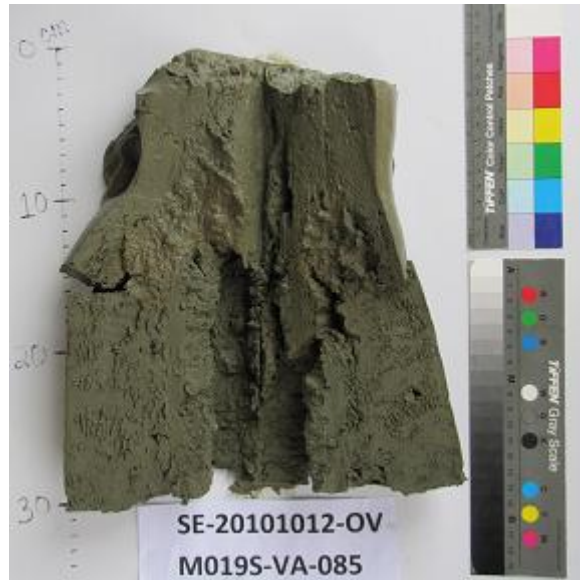
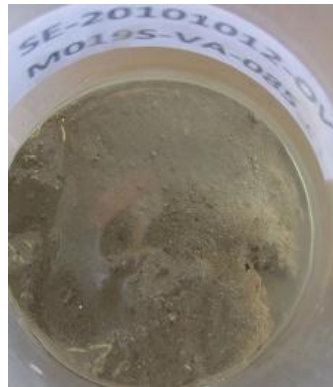
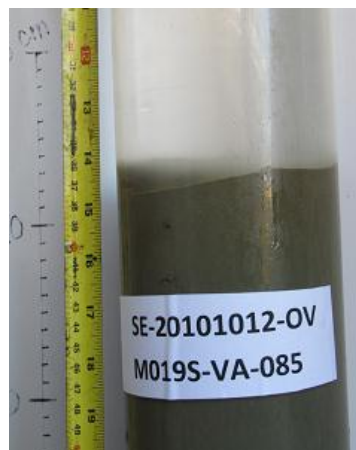
Station M019S

Cores recovered: 8 of 8

Recovery: 31 cm

Recovery: 29 cm

Description: Olive, very soft, homogenous silty clay, becoming soft.

Biota: Crab, polychaetes.

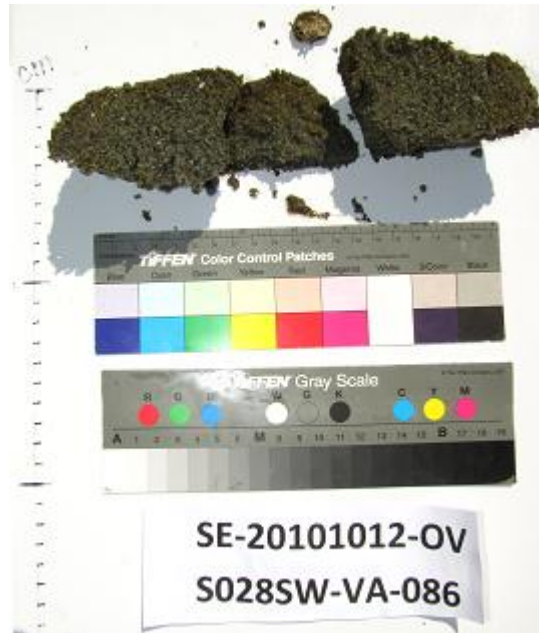
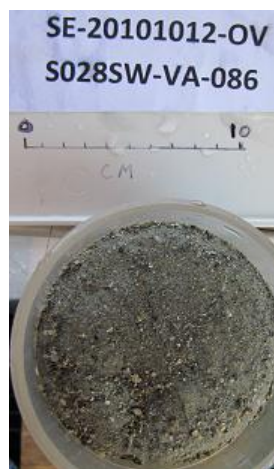
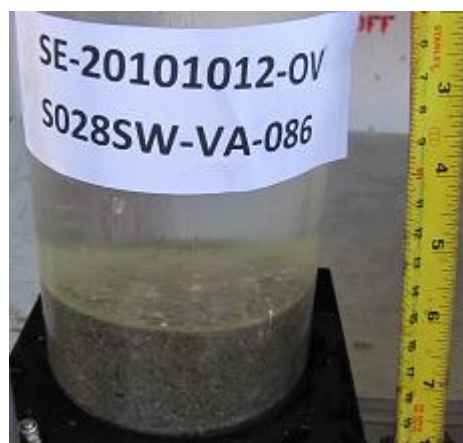
Station S028SW

Cores recovered: 2 of 8

Recovery: 53 cm

Recovery: 7 cm

Description: Black, very soft, homogenous sand.

Biota: None.

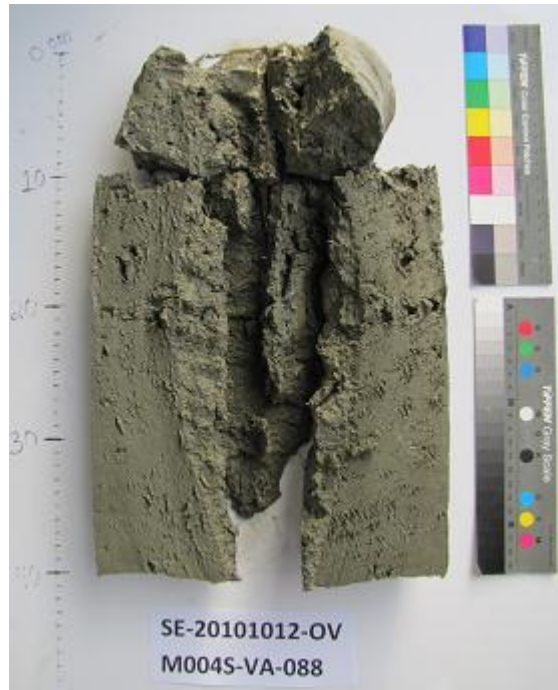
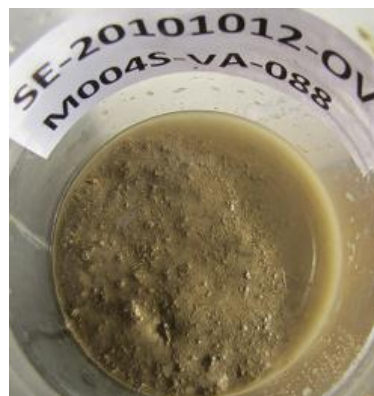
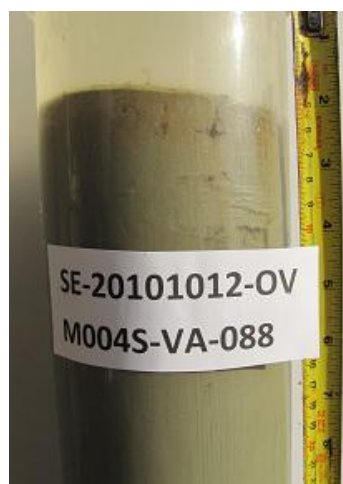
Station M004S

Cores recovered: 7 of 8

Recovery: 21 cm

Recovery: 39 cm

Description: Olive, very soft, homogenous sandy silt, becoming soft.

Biota: Polychaetes, sea urchin shell.

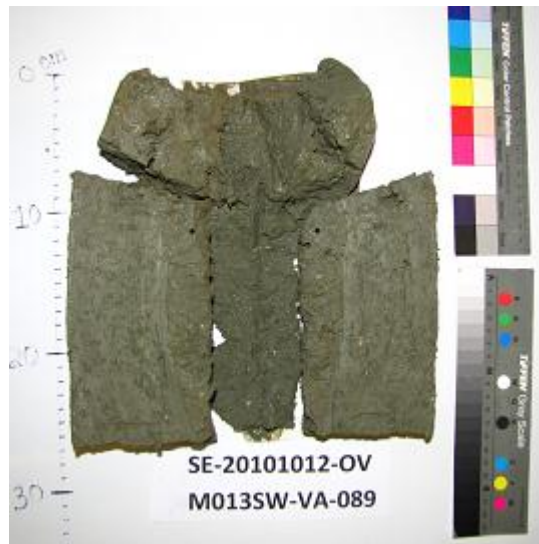
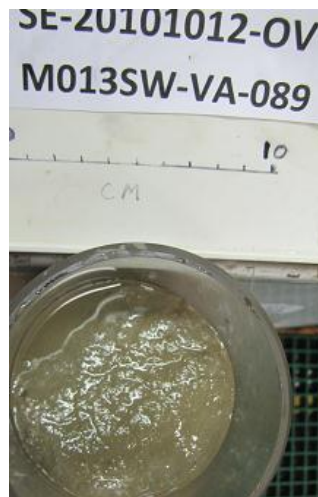
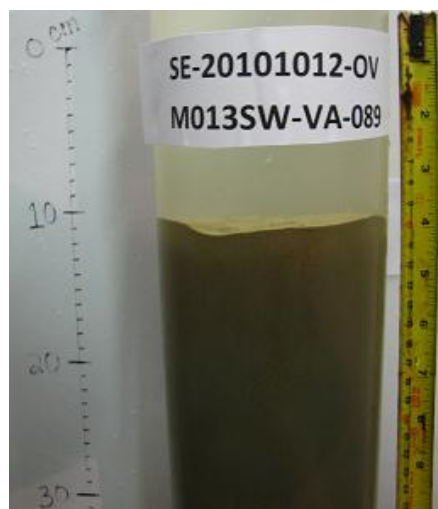
Station M013SW

Cores recovered: 8 of 8

Recovery: 32 cm

Recovery: 28 cm

Description: Olive grey, very soft, homogenous sandy silt, becoming very stiff.

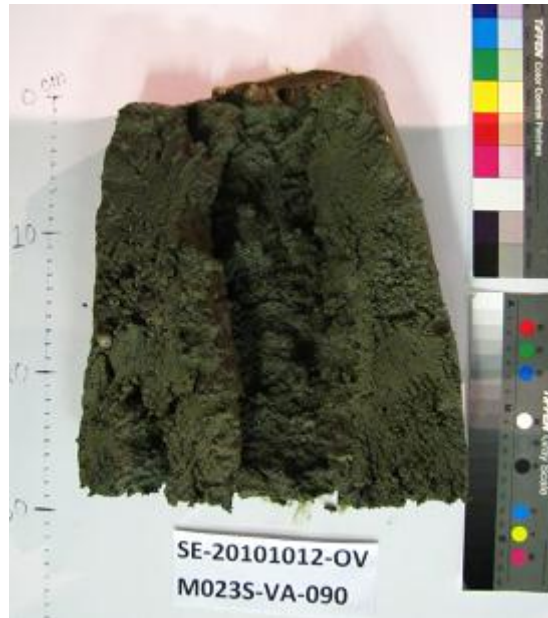
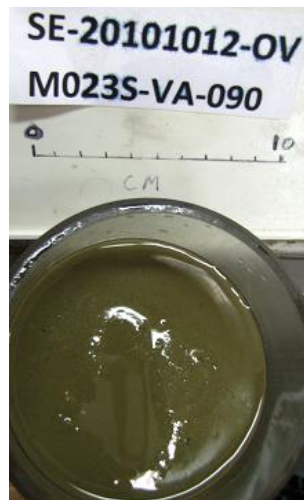
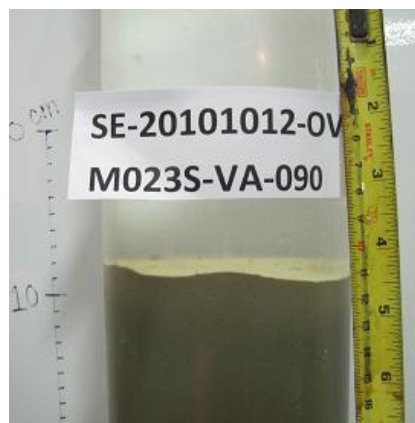
Station M023S

Cores recovered: 8 of 8

Recovery: 29 cm

Recovery: 31 cm

Description: Olive, very soft, homogenous silty sand, becoming stiff.

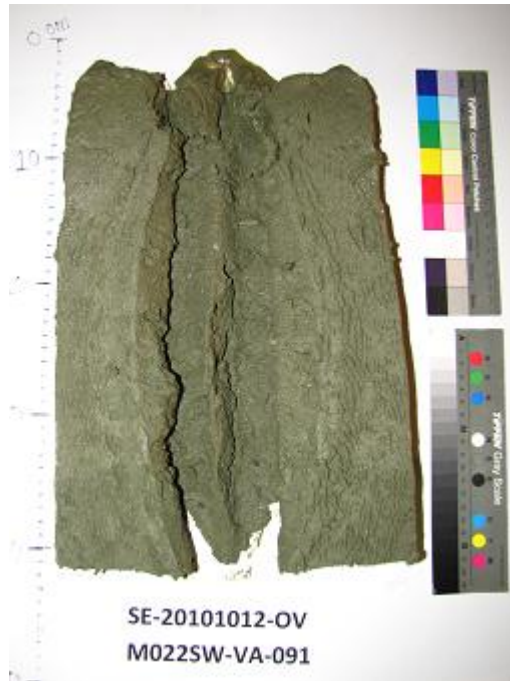
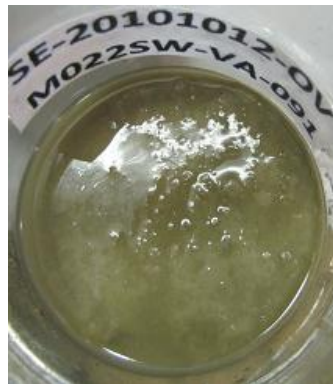
Station M022SW

Cores recovered: 8 of 8

Recovery: 19 cm

Recovery: 41 cm

Description: Olive, very soft, homogenous silty clay, slowly becoming very stiff.

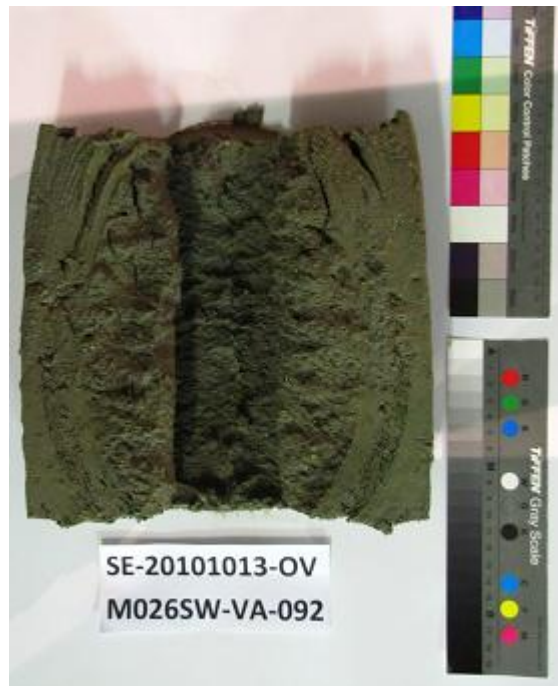
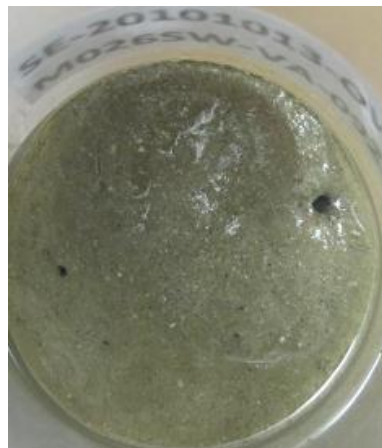
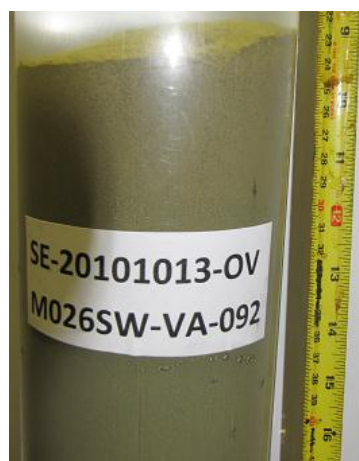
Station M026SW

Cores recovered: 6 of 8

Recovery: 31.5 cm

Recovery: 28.5 cm

Description: Olive grey, firm, homogenous silty sand, becoming very stiff.

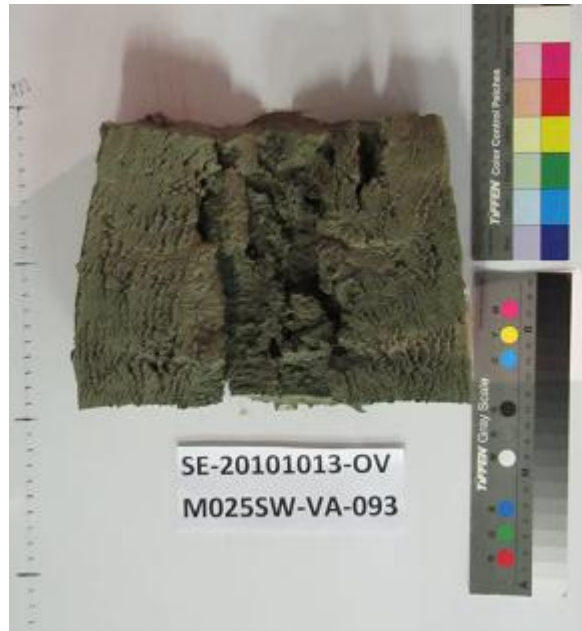
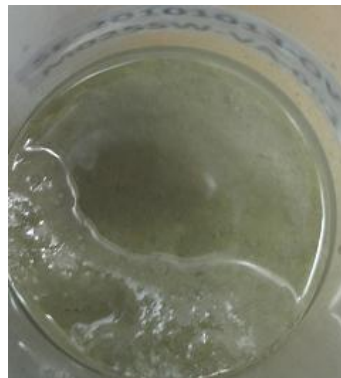
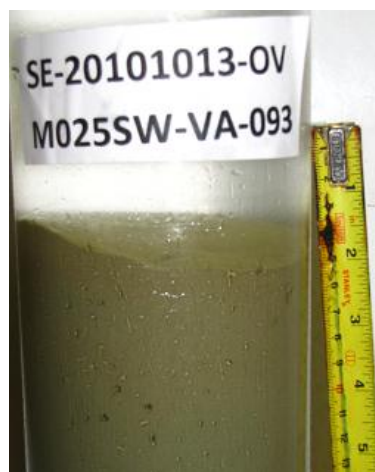
Station M025SW

Cores recovered: 8 of 8

Recovery: 38 cm

Recovery: 22 cm

Description: Top 3cm olive, very soft, homogenous silty clay, becoming stiff.
